Analysis of Fault Occurrences on HVDC Stations- A Case Study of Chandrapur-Padaghe HVDC Link

Manish Chaware (PG Scholar)

N. K. Singh (Associate Professor)

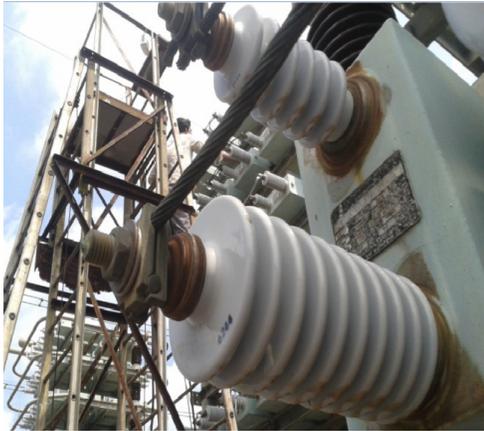
Fig 1.2 Filter capacitor bank without Lug

During my visit to the plant and switchyard I saw people directly connect filter banks in series with each other which is shown in fig. 1.2. Due to direct contact of link between two banks in case of high voltage surges because of heat and high temperature the link gets heated and damaged which results into break in operation of filters.

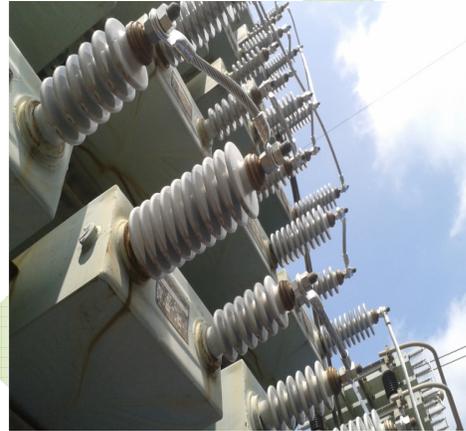
Fig 1.3 Filter capacitor bank with Lug

After understanding above frequently occurring problem I suggest to MSEB engineers to use the lug to link which connects two filter banks. Fig. 1.3 describe here when two banks connected by link which lugged properly the link is more tightly connected to the nut-bolt of insulator so that the reliability and quality of supply will enhanced.

Due to properly lugged cable even in case of high temperature the lug and nut-bolt not get loosed and link will not get damaged.

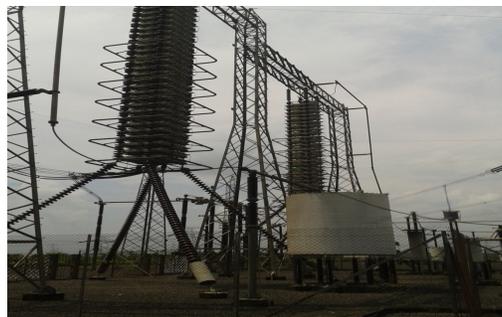
Fig. 1.4 Bird fault frequently occurs on this filter banks

Abnormal Condition: As shown in above figure these filter banks frequently facing bird fault which causes due to bird gets come in contact with two links of bank. Due to which surges are introducing in line and bank get tripped which results into increasing the harmonic distortion of line.

After analyzing the occurrences of bird fault, I suggest MSEB engineers that if we provide metal cage of plastic or rubber coating around the filter banks, bird will not come in contact with bank so that system will not face abnormal condition and supply reliability will be stable.
