FAILURE ANALYSIS OF CONNECTING ROD

Abstract— In the present work, a failed connecting rod from a motorcycle and a diesel generator was investigated for the root cause of and possible mechanisms leading to its premature failure. In addition to finding the root cause, the expectation from the study was to possibly improve the existing designs or practices to avoid similar failure in future. These results were validated using a finite element analysis. A scanning electron microscope was used for studying the microstructure and visual inspection was primarily utilized to determine the root cause of the failure. In conclusion, it was determined that the root cause for the premature failure of the connecting rod was the presence of scale built up inclusions, which lead to micro cracking during fatigue loading of the component

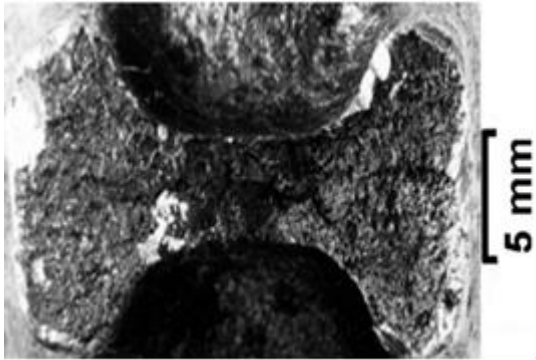
The analysis of the fracture consisted of a visual examination, hardness measurements and a metallographic examination. The specimen for the metallographic and scanning electron microscope (SEM) examinations was cut from the connecting rod shank near the fractured surface. The double T cross section of the shank's fractured surface is shown in the figure 1, and the rods microstructure is shown in figure2.

Figure 1. Fractured surface near the shank

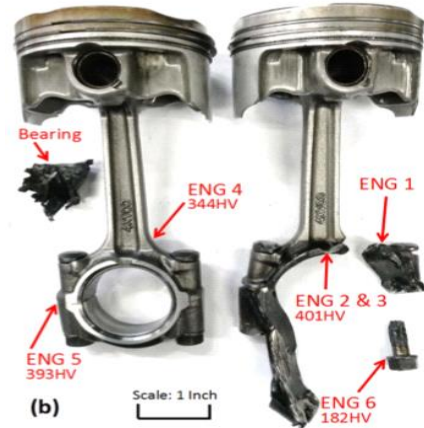
Fig 4. Connecting rod from the motorcycle

Whereas from the motorcycle engine the a visual inspection was conducted on the failed components figure 4, after they had been removed from the engine, as well as other components such as oil filter and sump. Statements were also taken form interview with people involved in the refurbishing the car prior to failure.

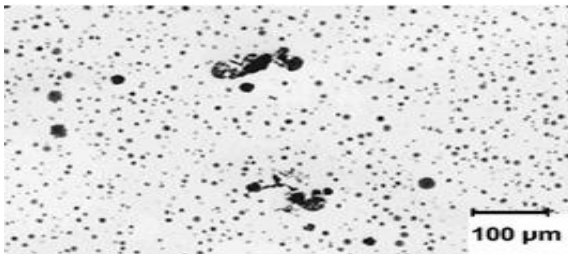
The microstructure shown in the figure 2 is typical for ductile iron (nodular graphite iron) with a fine lamellar perlite matrix and small inserts of ferrite (approximately 5%) around the graphite nodules.

fig 2. Specimen's microstructure small end of the connecting rod shank

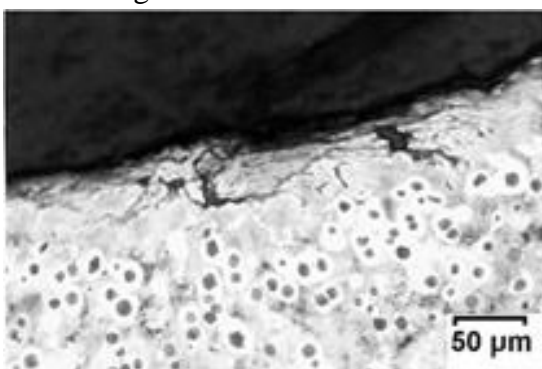
The whole surface of the connecting rod's two halves was examined carefully and numerous surface casting defects were found. One of which is shown the figure 3.

Fig 3. Casting defects on the surface of the connecting rod
