Paper ID: NITETMECH15

STUDY OF REMEDIES ON THE REASONS OF THE BENDING OF CAMSHAFTS

Amol Sanjeev Kulkarni
Department of Mechanical Engineering,
Solapur University/ N.B.N.S.C.O.E., Solapur, India.

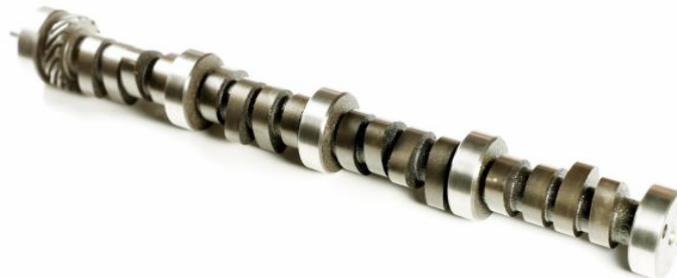
Fig.: Camshaft

A camshaft is a shaft having required number of cams over it. Camshafts are responsible for the accurately-timed fuel injections required by internal combustion engines. Camshafts have multiple cams on them, which are used to open valves through either direct contact or pushrods. A camshaft is directly coupled to the crankshaft, so that the valve openings are timed accordingly.

In internal combustion engines with pistons, the camshaft is used to operate poppet valves. The cam lobes force the valves open by pressing on the valve, or on some intermediate mechanism as they rotate. Camshaft Manufacturing is done mainly by casting process. The whole manufacturing process (casting) is carried out to form a desired camshaft. Camshaft is an important part in engine assembly.
